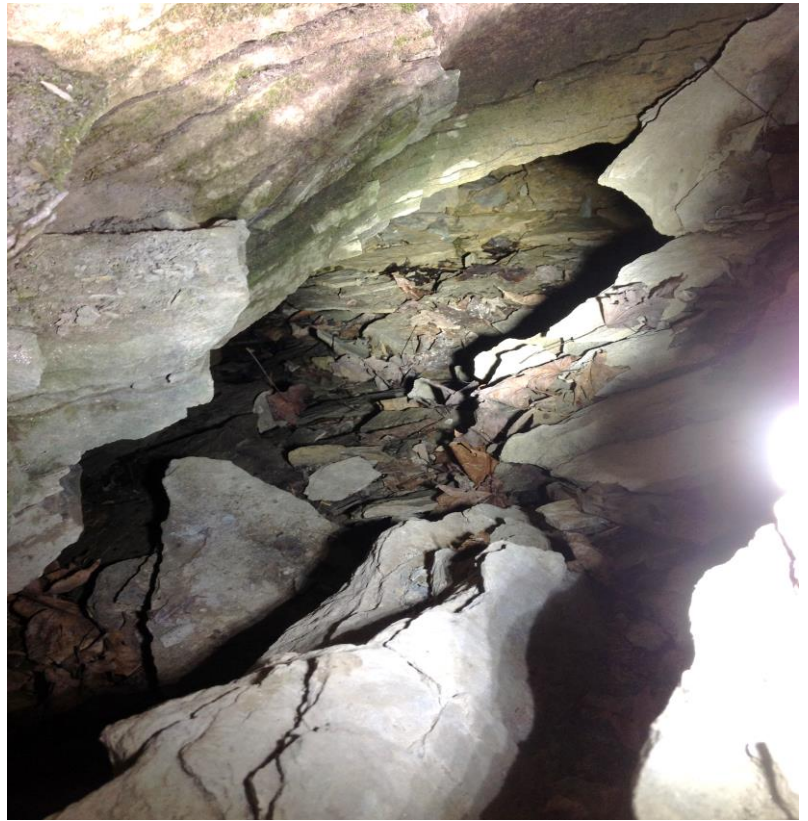
Portal 1

State: WV
County: Marshal
Segment: Majorsville
Opening height (ft.): 1
Opening width (ft.): 2.5
Orientation: Horizontal
Slope (°): 0
Observed length (ft.): 10
Internal height (ft.): 1
Internal width (ft.): 2
Entrance stable: No
Evidence of collapse: Yes
Ceiling stable: No
Amount of airflow: None
Airflow direction: N/A
Outside temp. (°F): 60
Internal temp. (°F): 60
Evidence of flooding: No
Canopy closure (%): 80
Distance to water (ft.): 100
Guano present: No
Entrance obstructed by vegetation: No
Entrance obstructed by spider webs: No
Risk of predation: Yes
Recommended for survey: Yes

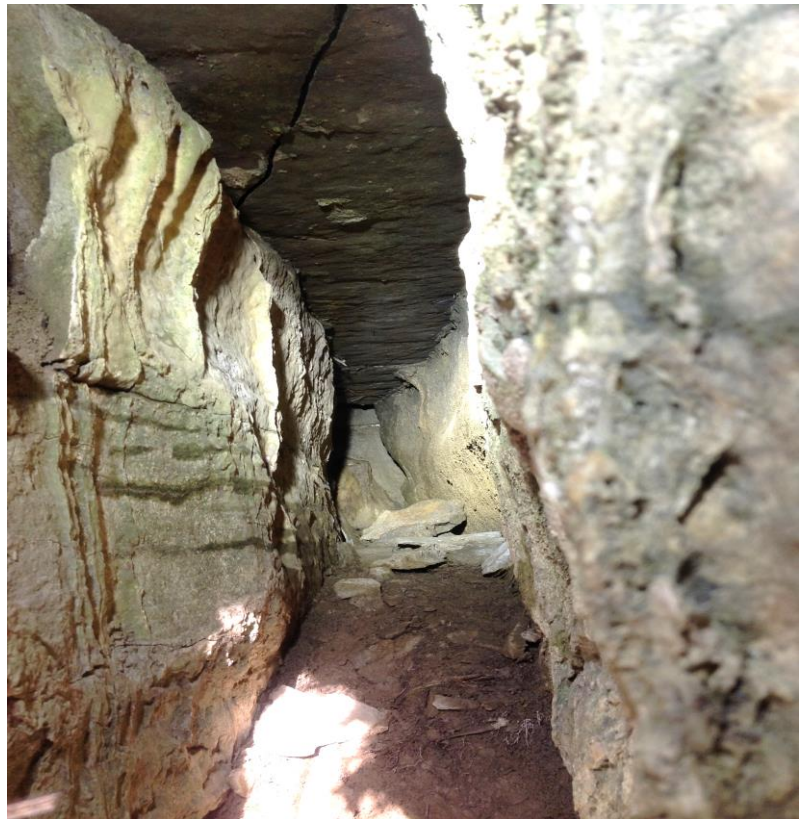
Portal 2

State: WV
County: Marshal
Segment: Majorsville
Opening height (ft.): 1.5
Opening width (ft.): 1
Orientation: Horizontal
Slope (°): 0
Observed length (ft.): 10
Internal height (ft.): 1
Internal width (ft.): 2
Entrance stable: Yes
Evidence of collapse: Yes
Ceiling stable: Yes
Amount of airflow: None
Airflow direction: N/A
Outside temp. (°F): 60
Internal temp. (°F): 60
Evidence of flooding: No
Canopy closure (%): 80
Distance to water (ft.): 85
Guano present: No
Entrance obstructed by vegetation: No
Entrance obstructed by spider webs: No
Risk of predation: Yes
Recommended for survey: Yes

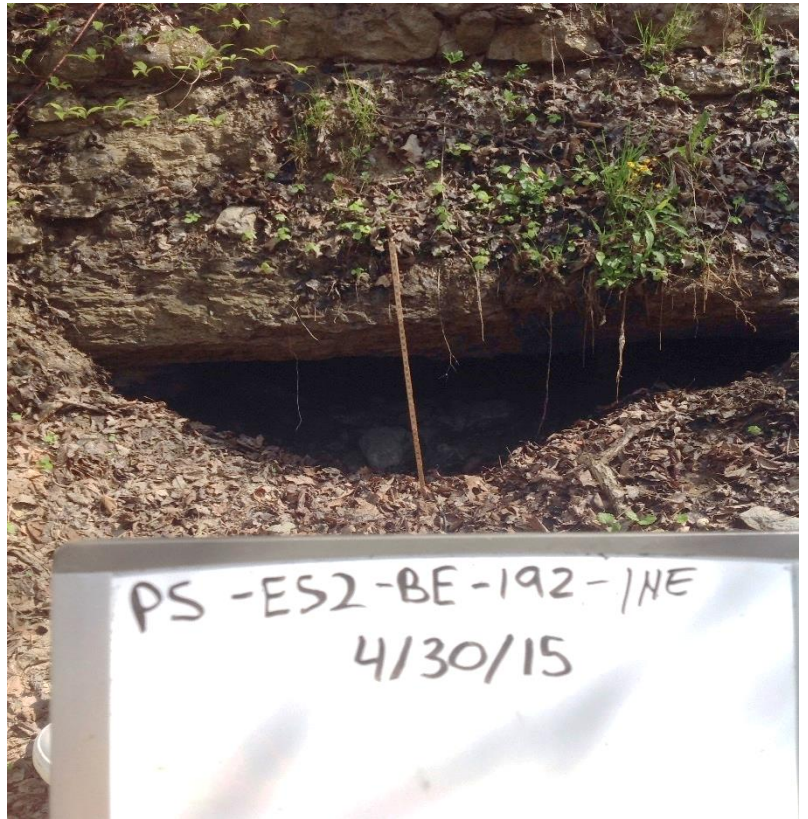
Portal 3

State: OH
County: Marshal
Segment: Clarington
Opening height (ft.): 3
Opening width (ft.): 7.5
Orientation: Horizontal
Slope (°): 5
Observed length (ft.): 100+
Internal height (ft.): 5
Internal width (ft.): 10
Entrance stable: Yes
Evidence of collapse: Yes
Ceiling stable: Yes
Amount of airflow: Slight
Airflow direction: Out
Outside temp. (°F): 65
Internal temp. (°F): 65
Evidence of flooding: Yes
Canopy closure (%): 30
Distance to water (ft.): 30
Guano present: No
Entrance obstructed by vegetation: No
Entrance obstructed by spider webs: No
Risk of predation: Yes
Recommended for survey: Yes

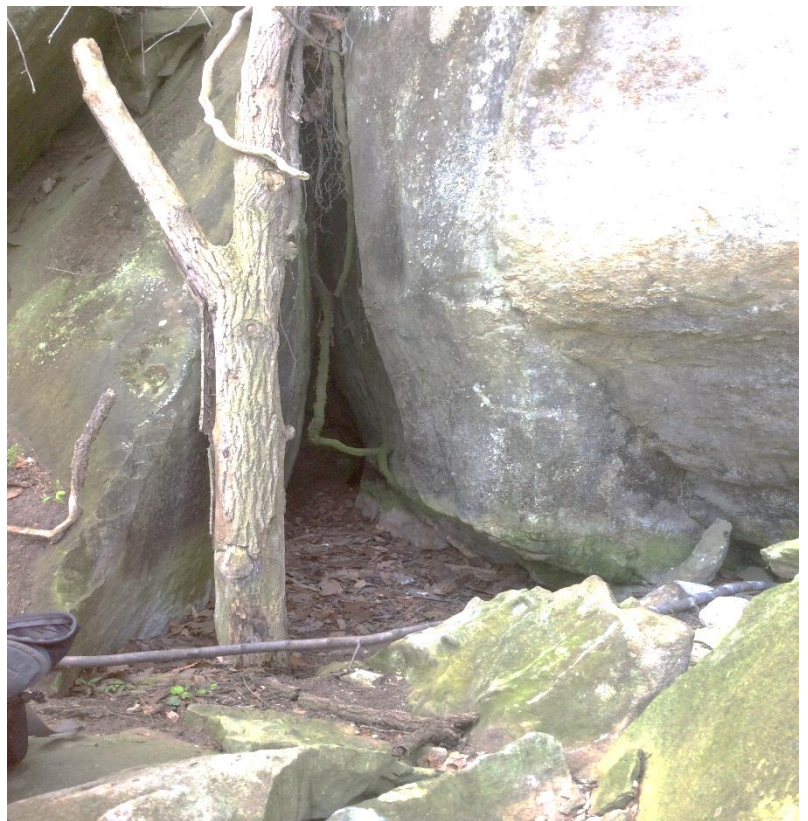
Portal 4

State: WV
County: Wetzel
Segment: Sherwood
Opening height (ft.): 2.5
Opening width (ft.): 1.5
Orientation: Horizontal
Slope (°): 5
Observed length (ft.): 3
Internal height (ft.): 0.7
Internal width (ft.): 0.5
Entrance stable: Yes
Evidence of collapse: No
Ceiling stable: Yes
Amount of airflow: None
Airflow direction: N/A
Outside temp. (°F): 59
Internal temp. (°F): 57
Evidence of flooding: No
Canopy closure (%): 30
Distance to water (ft.): 130
Guano present: No
Entrance obstructed by vegetation: No
Entrance obstructed by spider webs: No
Risk of predation: Yes
Recommended for survey: No
